Correspondence

Malfunction of an adjustable pressure limit valve

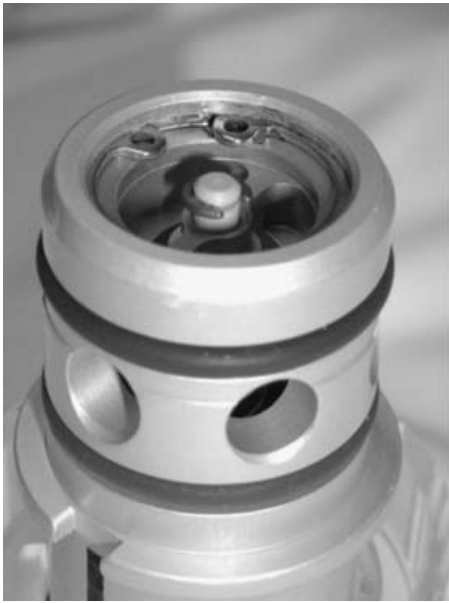
Figure 1.
Visible rust on the lower end of the adjustable pressure limit valve, which led to an intermittent blockage of the valve. The loss of the gas-release ability caused an excessive build-up of the gas pressure in the breathing circuit.

another one. No harm came to the patient. On subsequent inspection of the APL valve, its lower end appeared to be rusty (Fig. 1).

The cause of the malfunction of the APL valve was finally found by the Siemens technicians after the second malfunction incident. Excessive humidity in the breathing system had led to rust on the spring mechanism of the APL valve (Fig. 1), which itself caused the valve to stick. Possible sources for the humidity might be the sterilization process or the patient's expiratory gases accumulating in the patient cassette. In the latter case, a special dehydration filter placed on the connection of the expiratory patient tubing with the patient cassette is required. These filters have been ordered with the intention to be used routinely from now on in our department. Furthermore, increased attention is

The application of only light pressure on the lower end of the valve screw was sufficient to loosen the blockage of the valve. The unpredictability and especially, as in this report, the lack of reproducibility of intermittent malfunctions of parts of ventilatory equipment can lead under special circumstances not only to injury to the patient, but to medicolegal consequences for the anaesthesiologist in charge, if in a subsequent investigation, the malfunction cannot be verified. This case report also emphasizes the fact that physicians should not self-investigate the faulty equipment during a critical incident. It is wiser to leave it to specialists

paid so that no humidity remains in the breathing system following the sterilization process. The Siemens technicians subsequently acknowledged that a similar incident had already occurred in another hospital in Greece.

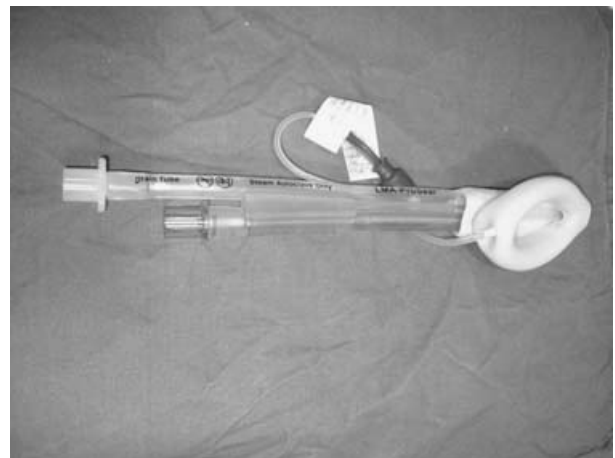
A ProSeal LMA was used to secure an airway after induction of general anaesthesia. After cuff inflation, the anaesthetic assistant picked up the anaesthetic breathing circuit to connect it to the ProSeal LMA, and encountered two possible connector choices at the distal end of the LMA. We then noticed that the drain tube of the LMA also had a 7 mm endotracheal tube connector securely attached to its distal end (Fig. 1). The breathing circuit was

Figure 1. ProSeal LMA with two airway connectors, one at the distal end of reinforced LMA tube and the other unexpected connector attached to the drain tube. LMA: laryngeal mask airway.

connected to the appropriate airway connector, avoiding the unintended oesophageal ventilation and insufflation. The unnecessary connector was removed from the drain tube to avoid future incident.
