The Graveney boat

ANGELA CARE EVANS and VALERIE H. FENWICK

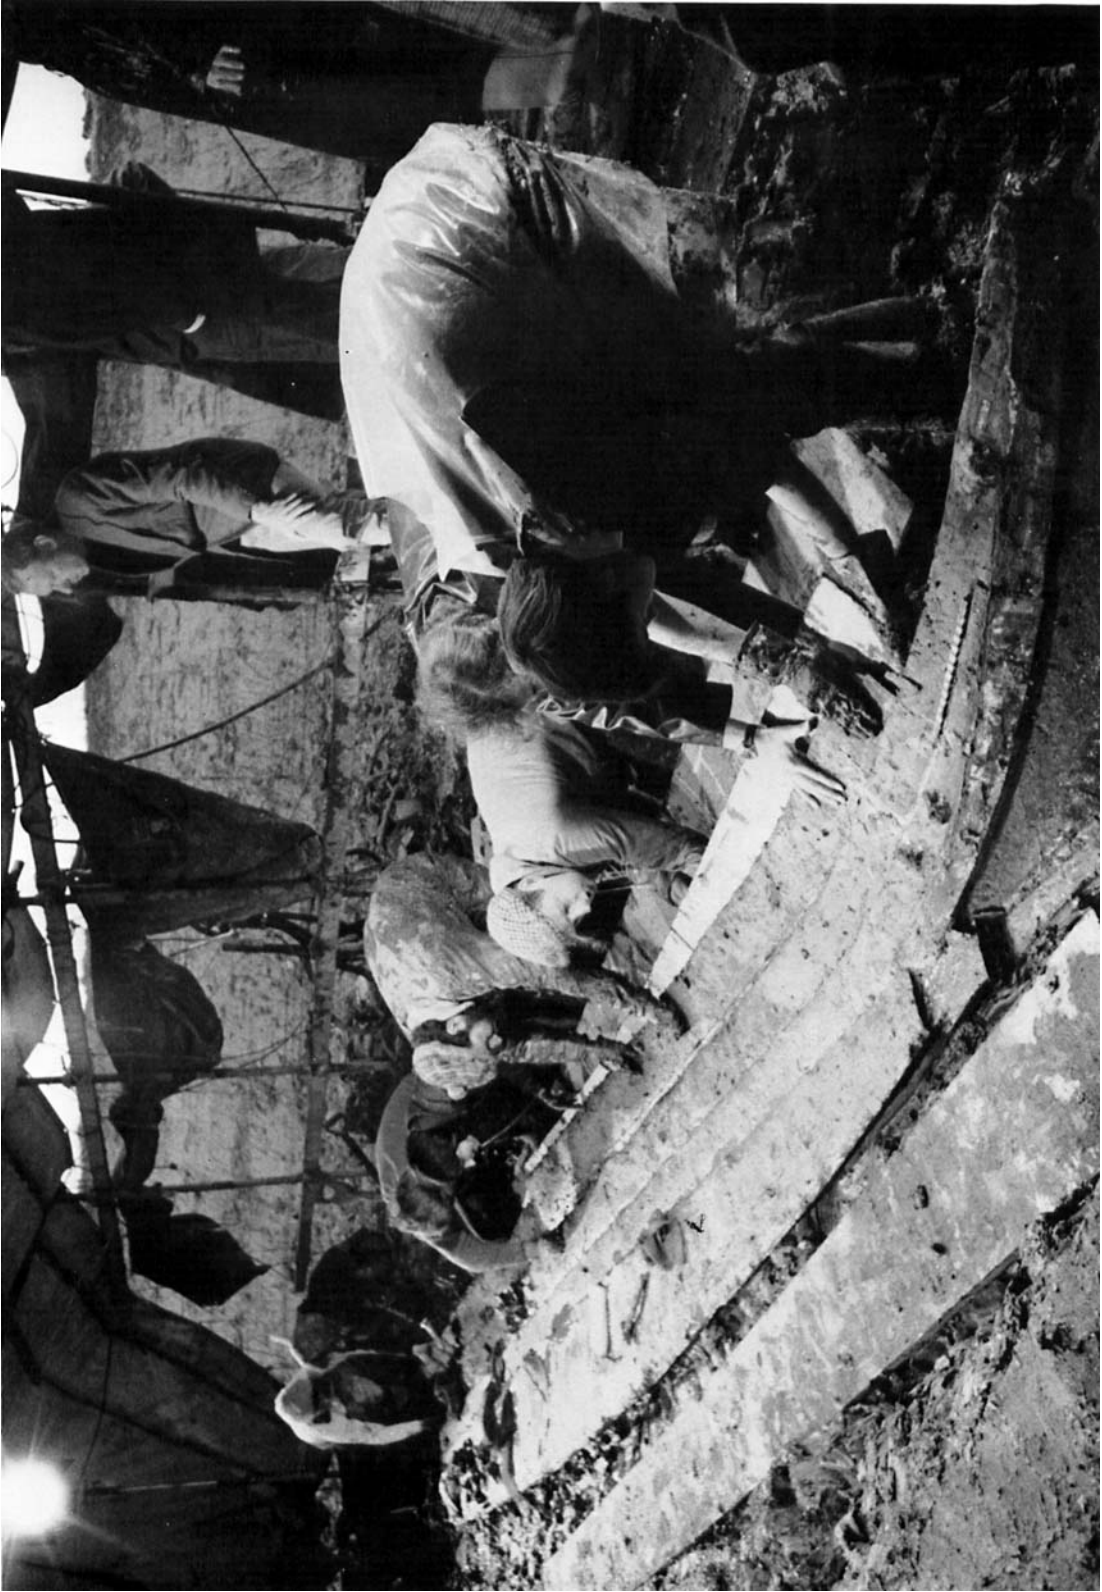
PLATE XIV: THE GRAVENEY BOAT
Lifting part of strake 3 starboard

with the inside surface of the sternpost, contrary, for example, to the Sutton Hoo ship where the stem and sternposts expand as the curve moves away from the scarf (Phillips, 1940, pl. xxxiv).^{*} The sternpost is also remarkable for the two pairs of parallel grooves on its inner surface (PL. XIII and FIG. 2). The function of these grooves was to permit the use of through fastenings to secure the hood-end of garboard and second strakes. Basically this sternpost is plank-on-edge with the lower strakes meeting at a shallow angle. The difficulty of making a neat join of clinker-shell and sternpost is neatly solved. The aft extremity of each hood-end plank is cut off and the plank is carefully let into a rabbeted area in the plank above it, so that a continuous hood-end of uniform thickness is offered to the sternpost. This can be seen on the right of PL. XIV.

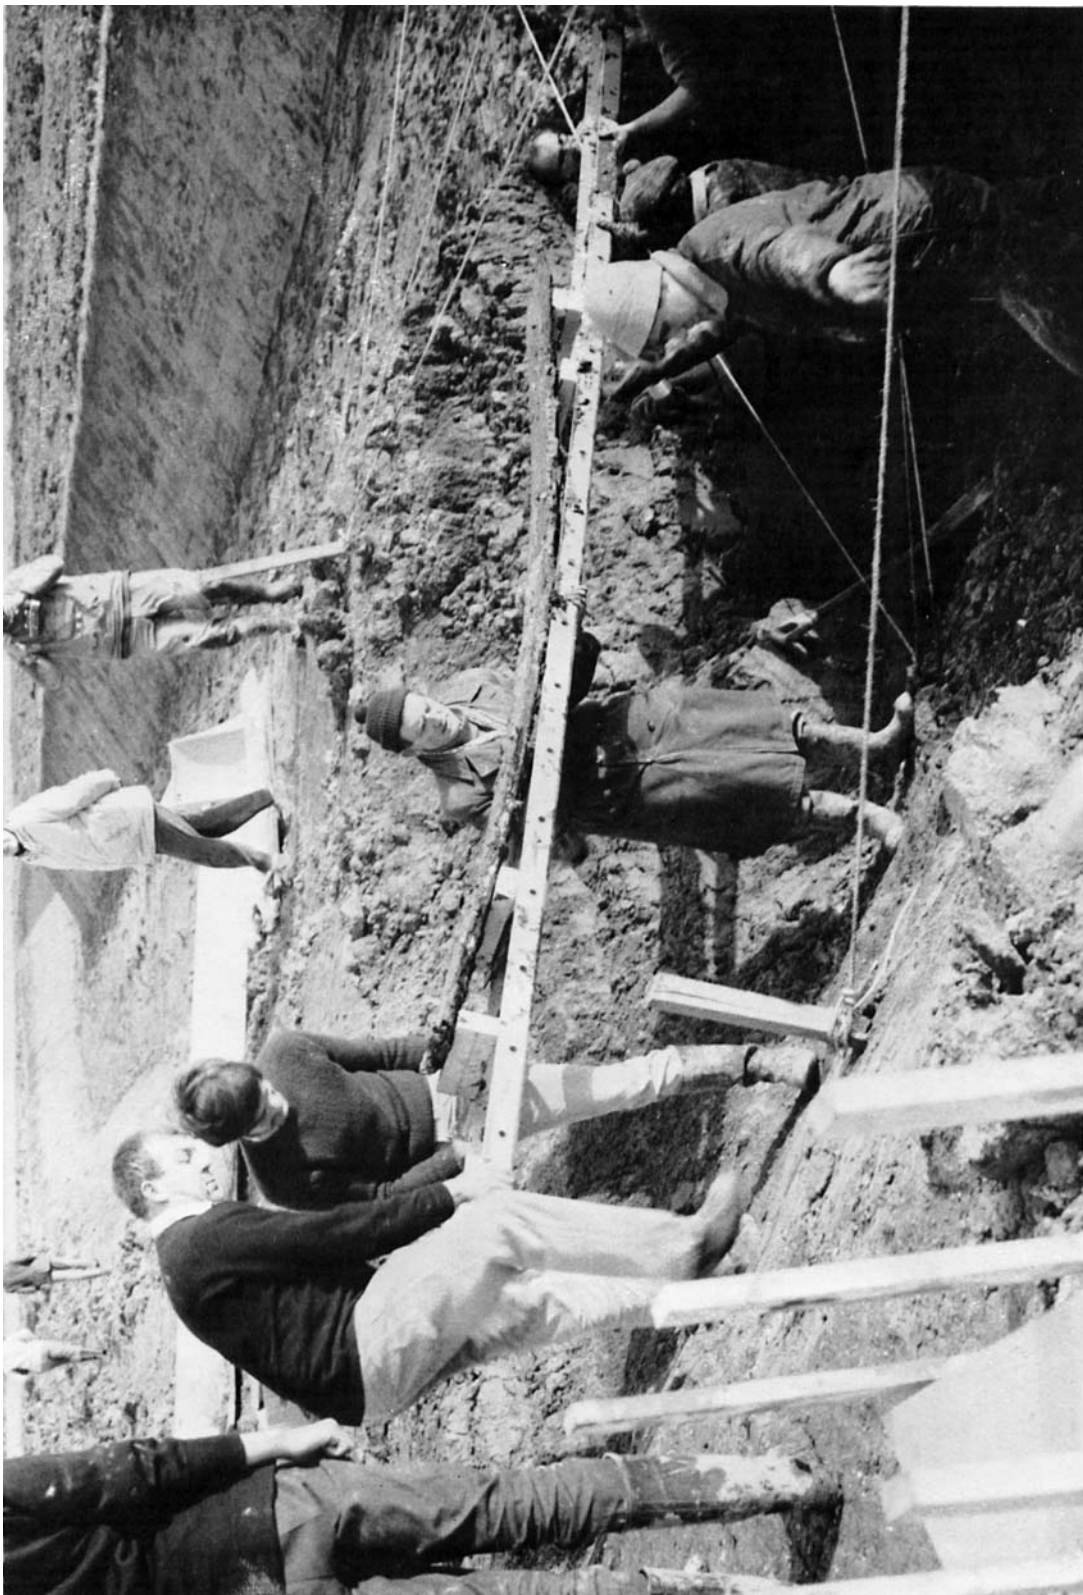
PLATE XV: THE GRAVENEY BOAT
Carrying a length of planking—chocks support its curve

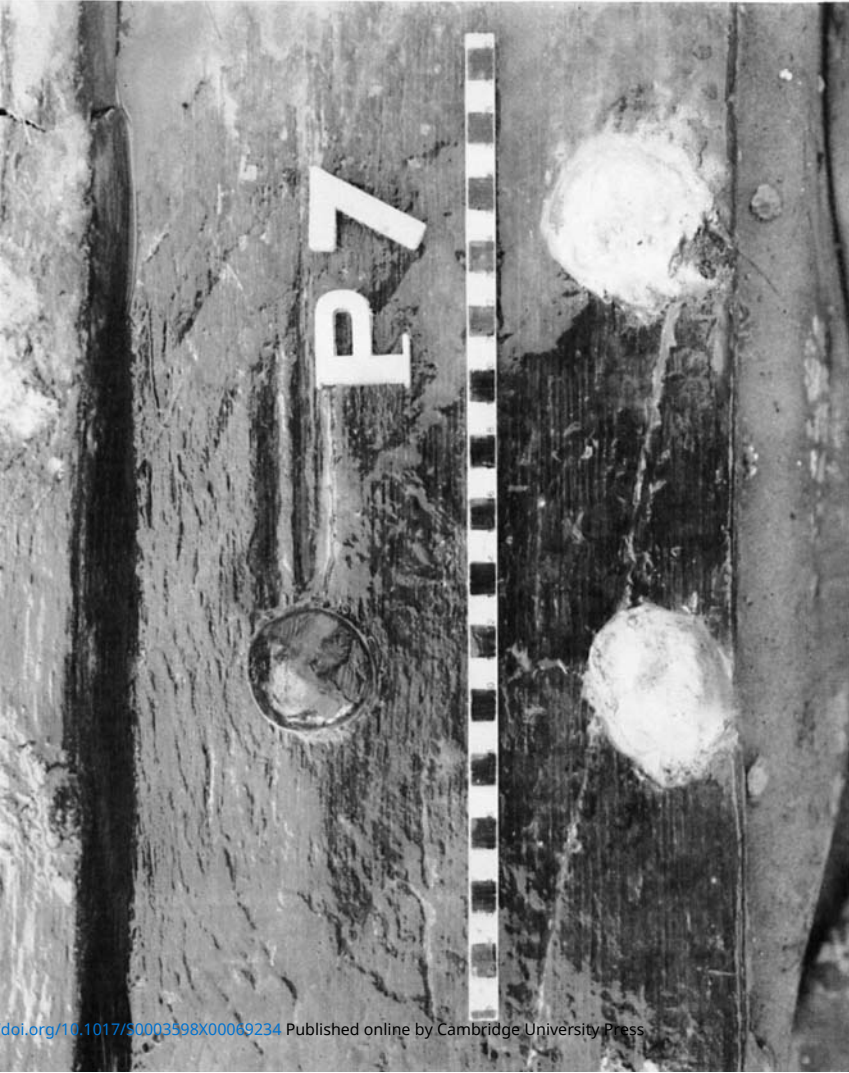
(a) *Field-recording: knobbed treenail projecting outside the boat*

Because of the shortage of time and increasingly muddy conditions, a recording code on Dymo tape was evolved for the final labelling of the lifted planking.* This was supplemented by photographs in which the timbers were readily identifiable through the use of movable plastic letters and numbers and took the place of normal written records (PL. XVII*a*).

The 'painter' initially gave the impression that the stem post had been preserved, but it was soon found that the great majority of the plank-joints had their outer edges facing the surviving end which should thus be the stern of the vessel. The plank-joints are a simple scarf fastened by one, or exceptionally two, rivets. The planking was radially cut and averaged 2.8 cm. in thickness. The strakes are composite, the lower made up originally of four lengths of timber and the upper of perhaps five or six. Although only eight strakes survived, the upwards projection of the fifth frame on the port indicated that at least two strakes had been lost (PL. XIII). The strakes had been fastened at approximately 15 cm. intervals with round-headed iron nails. The shanks of circular section were clenched inside the boat over roughly square roves. The floor-frames are massive and closely spaced with an average distance of 48 cm. between them. They have a rectangular cross-section, are more than 20 cm. high over the keel and are between 9 and 14 cm. broad. Most are carefully nibbed over the strake-lands. They were fastened to alternate strakes by finely shaped treenails. These have faceted heads which projected outside the boat (PL. xviii). In profile they resemble champagne

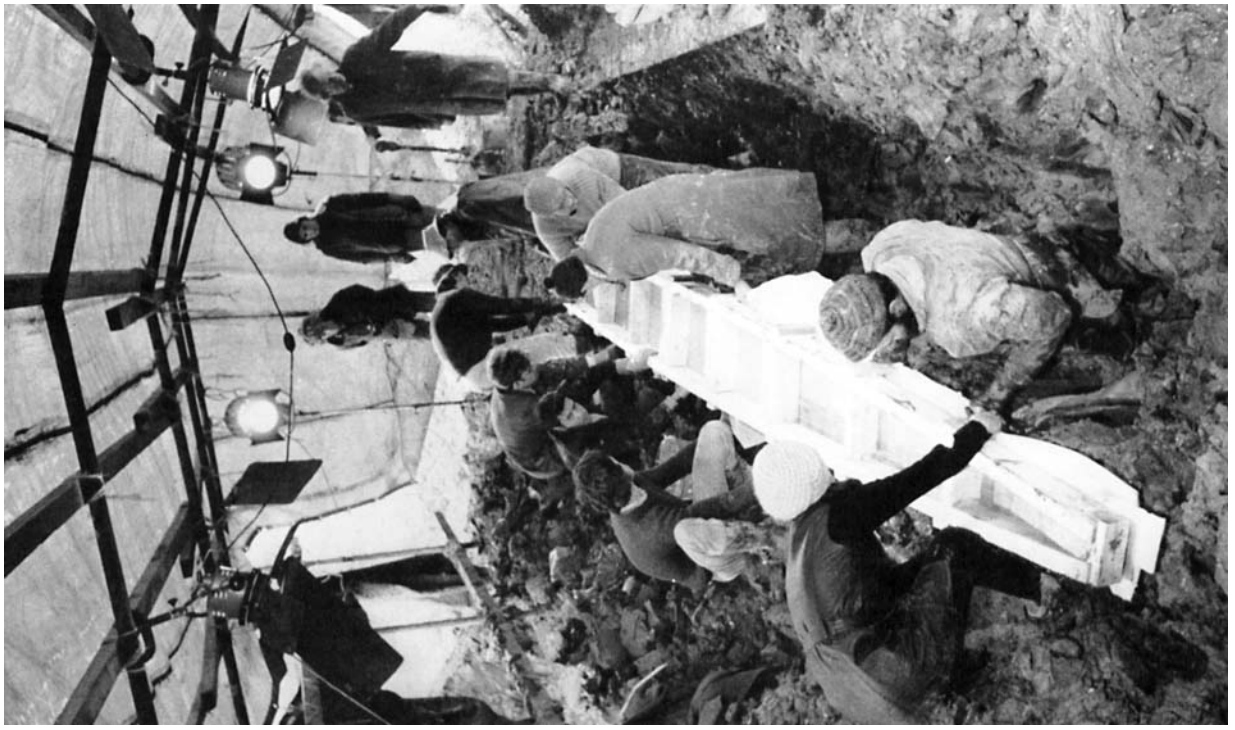
b

(b) *Laying the cradle on top of the keel*

waist deep along the starboard edge of the keel with a shallow one to port, a paper template of the upper surface of the keel was drawn and a rigid wooden coffin-like support was made from this. The slight curvature of the keel was packed with plastic foam and the rigid wooden 'coffin' was then set on top of the protected surface of the keel (PL. XVII*b*). Wooden battens projected downwards at 60 cm. intervals along its length and the keel was undercut at corresponding intervals so that a sandwich of marine ply, thick plastic foam and webbing could be pushed through and fastened to the battens. Because of the fragile condition of the vital scarf with the sternpost, an elaborate splint was bandaged into position using a massive plastering trowel to force the webbing strips through the mud. Finally a team in each trench undercut the keel simultaneously to port and starboard until it reached a point of balance on a narrow ridge of mud. The heavy keel was then rolled gently through 180 degrees down on to the arms of the starboard team and, inverted on top of its 'coffin', was carried by all hands to the top of the bank where it was cleaned and photographed before being wrapped in plastic foam and polythene tubing (PL. XVII*b*).

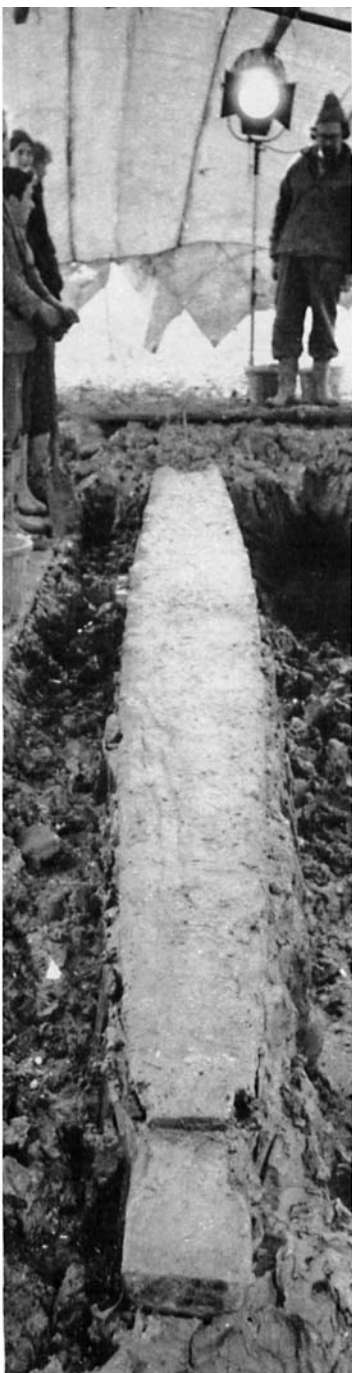
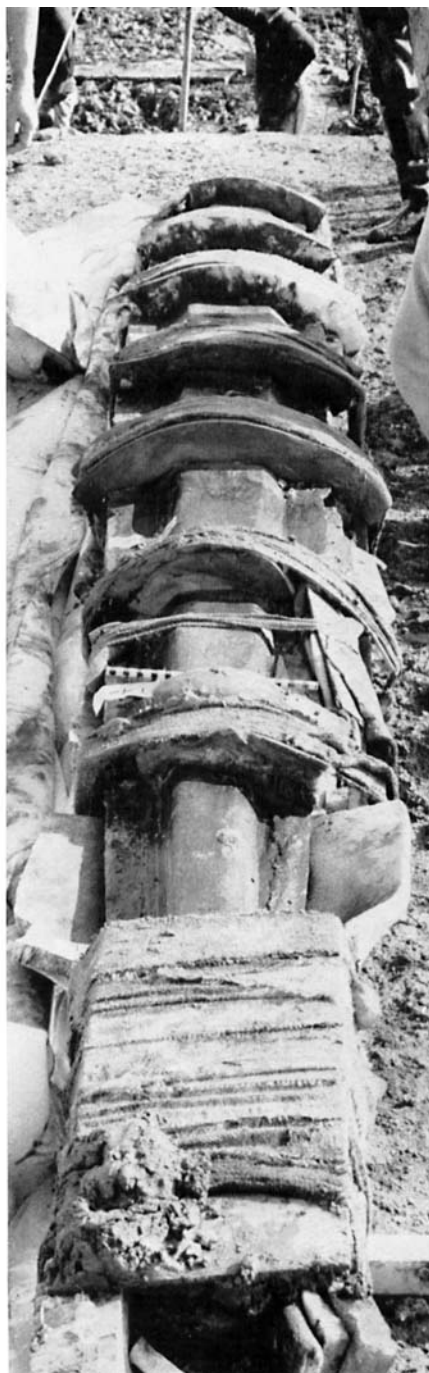
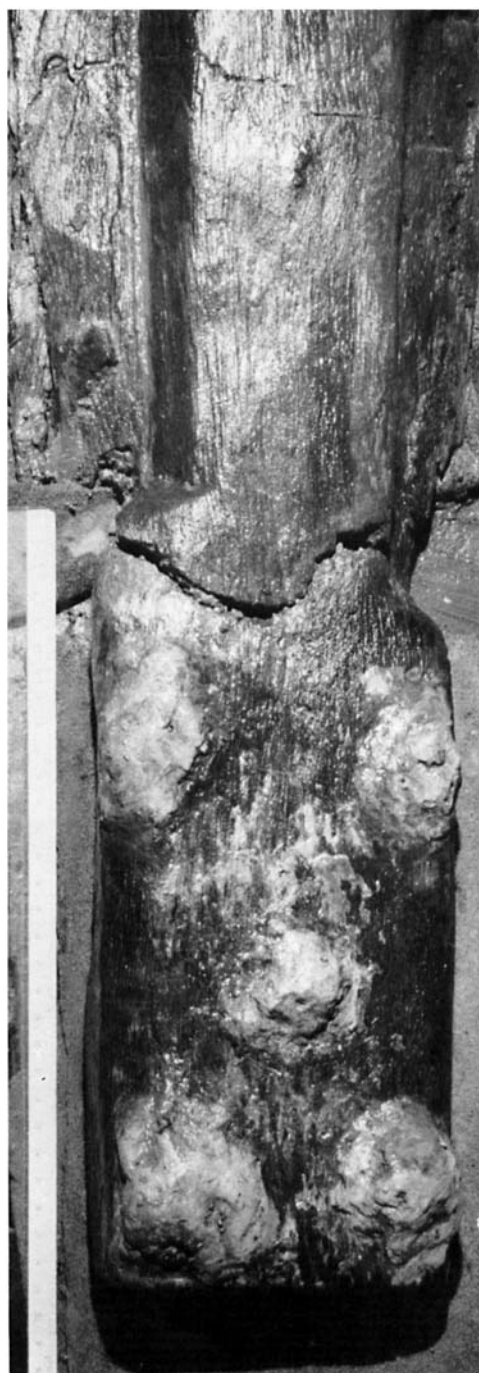
PLATE XVIII: THE GRAVENEY BOAT

*(a) Fish-shaped keel: sternpost scarf in foreground. (b) Inverted keel: splinted scarf in foreground.
(c) Beneath keel: scarf with sternpost showing quincunx of rivets*

Only 10 m. of the boat survived but it can be estimated that the original length was more than 14 m. with a beam of less than 3 m. The plank keel (PL. XVIII*a*) is fish-shaped in plan with a shallow, bevelled rectangular lower profile (FIG. 2). It is calculated that its original length was approximately 7.5 m. and amidships it measured 44.5 cm. wide. It was about 7 cm. thick throughout its length. The lower profile tapers gradually fore and aft from its maximum width of about 14.5 cm. amidships. It expands suddenly at its short scarf with the sternpost to which it is fastened with a quincunx of rivets (PL. XVIII*c*). The horizontal scarf is only 24 cm. long. The sternpost is remarkable in shape and so far unparalleled; 90 cm. aft of its scarf with the keel plank, the tapering lower edge of the post turns through a sharp angle and forms a distinct heel (PL. XIX *a,b*). The upward curve of the cutwater is, therefore, in a converging line

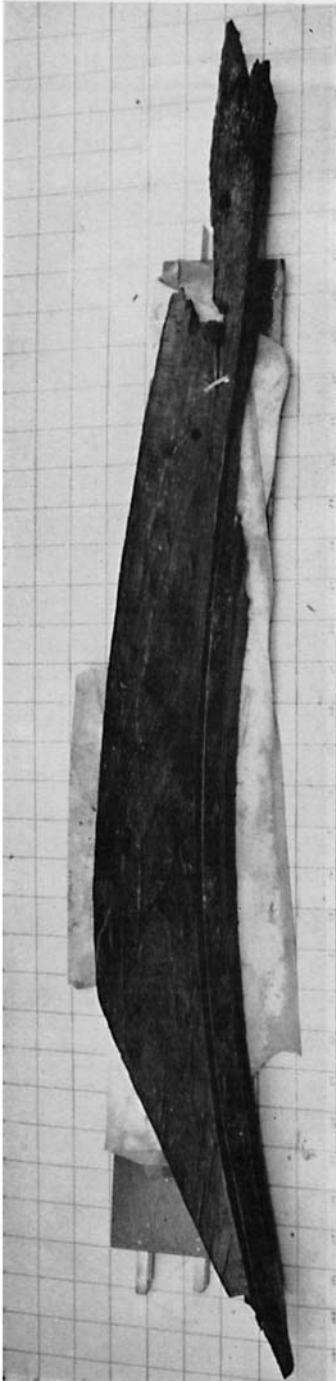
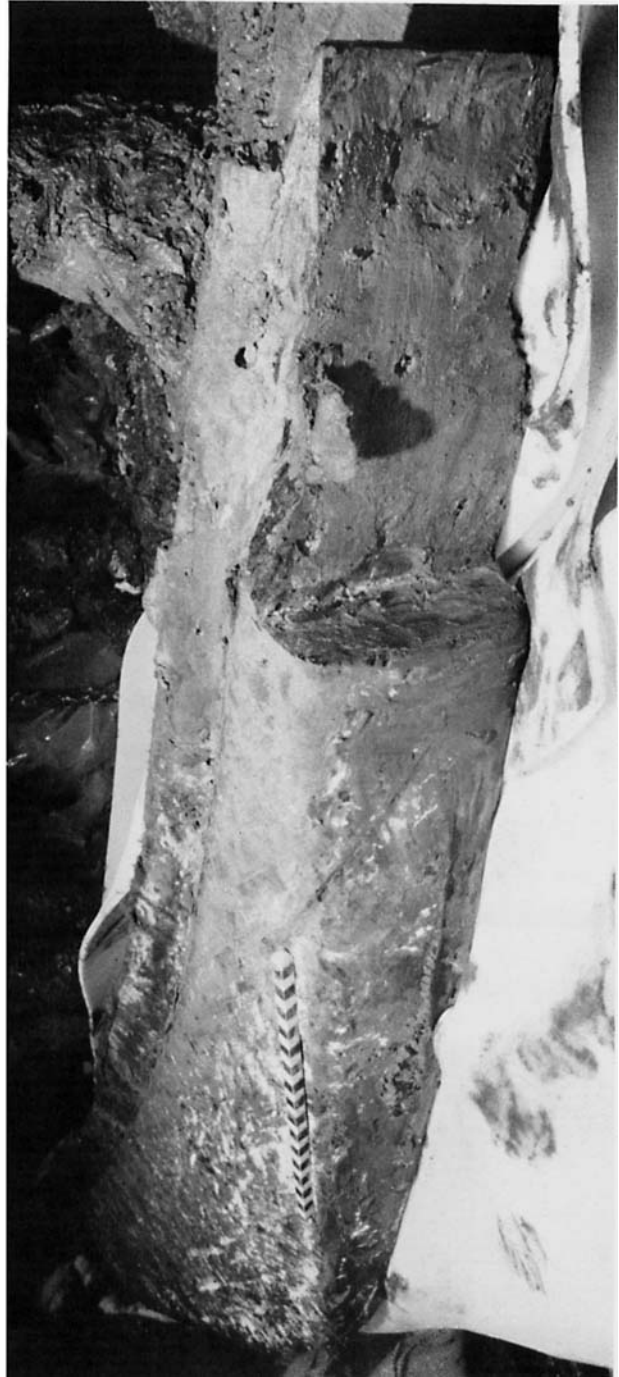
PLATE XIX: THE GRAVENEY BOAT

(a) Sternpost: scarf at bottom of photograph. (b) Sternpost scarf showing tapering lower edge of cutwater
See pp. 89–96

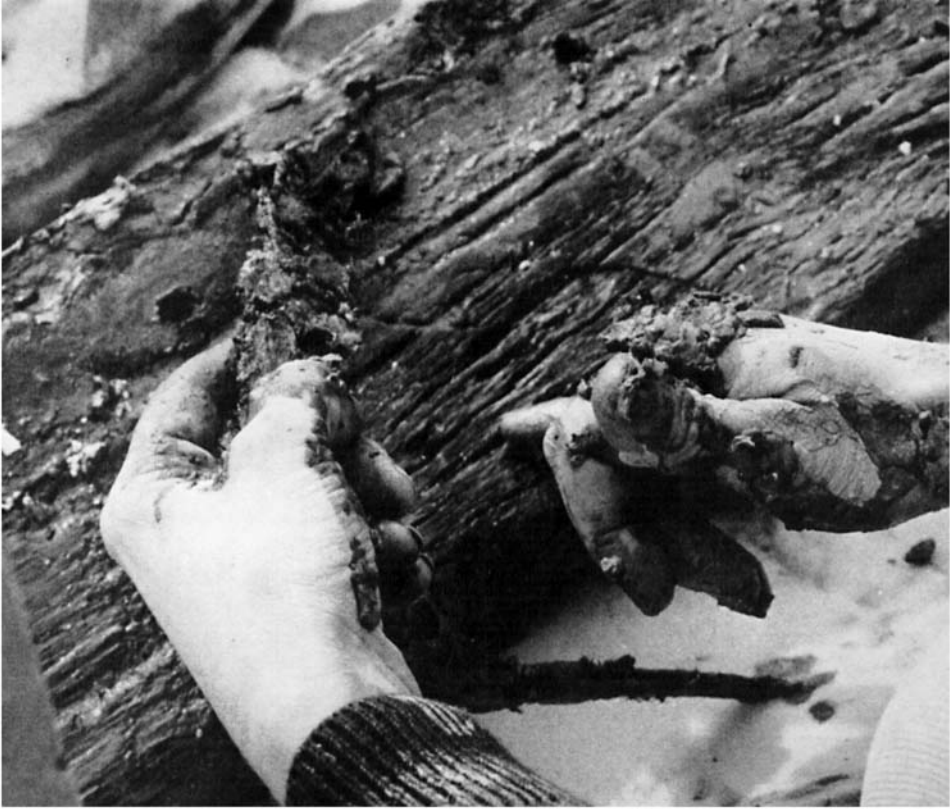
(a) Luting of animal hair pierced by clench-nails. (b) Withy rope found beneath the boat (14 cm. long)
See pp. 89-96

During the construction of the boat a luting of felted cattle-hair was inserted between sections, including the scarf of keel and sternpost which had no stopwater. Luting also filled plank joints and the lands between strakes. PLATE xx*a* shows how the metal fastenings perforated this layer. In some instances a luting-cove could be seen to run along the centre of the land. In addition to the luting, caulking of twisted hair was found in places.
