Effect of laser drilling process on combustor liner effusion hole quality

Keywords: effusion cooling; laser drilling; TBC; combustor

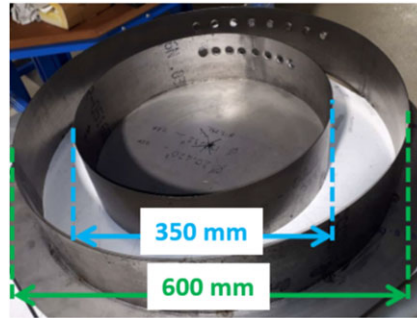
Figure 1. Combustor liner dummy parts.

Within the scope of this study, two sheets of $\text{Ø}350$ and $\text{Ø}600$ mm representing the diameters of the combustion chamber liners from 1 mm Hastelloy X sheet material were bent circularly (see Fig. 1). Later, the produced parts were coated with 0.100 mm metallic bond (NiCrAlY) and 350 μm ceramic coating (8% YSZ) by APS. Effusion hole drilling studies were carried out using a ytterbium fiber laser (Laserdyne 795 XL CNC λ : 1.06 μm , Origin: USA) on the inner surface of the cylindrical part coated with the thermal spray method.

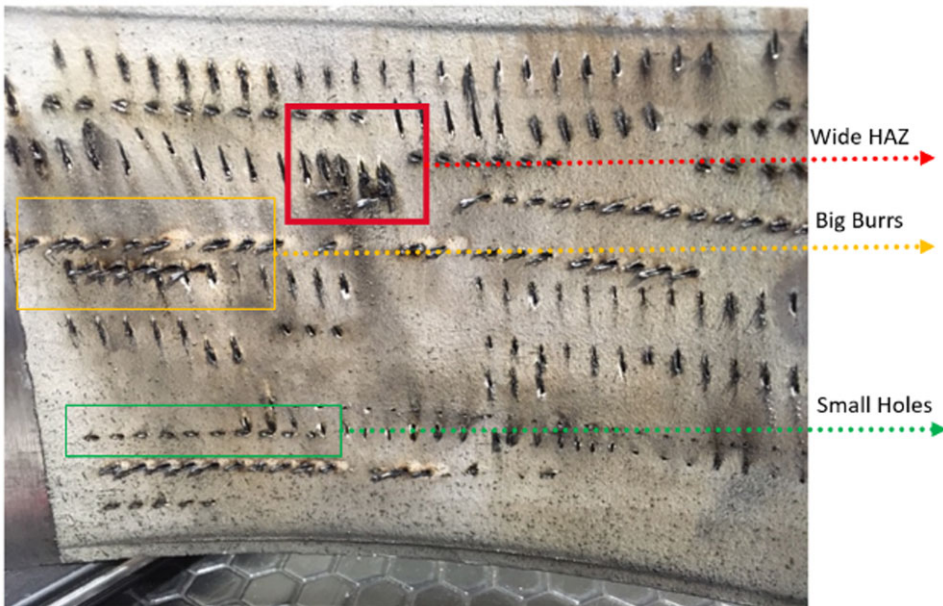
Figure 2. Laser trials, high heat-affected zone (HAZ), big burrs, small holes.

The studies started with the visual inspection of the holes created on the plasma surface initially using the existing parameter sets. In these visual inspections, the hole shape defects and the amount of burr on the coating were checked (see Fig. 2).

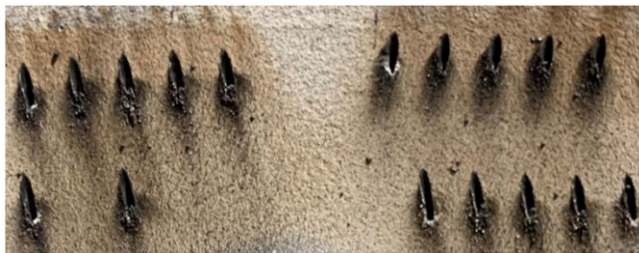
Figure 3. Burr accumulation at the bottom of the hole.

Afterwards, a long-term trial phase was started in order to reduce or prevent such defects. After these trials, the parameter set with the least burr formation on the coating surface and no shape defect was determined. After this stage, studies on the metallographic results started. Figure 3 shows the amount of burr resulting from effusion holes drilled in a row.

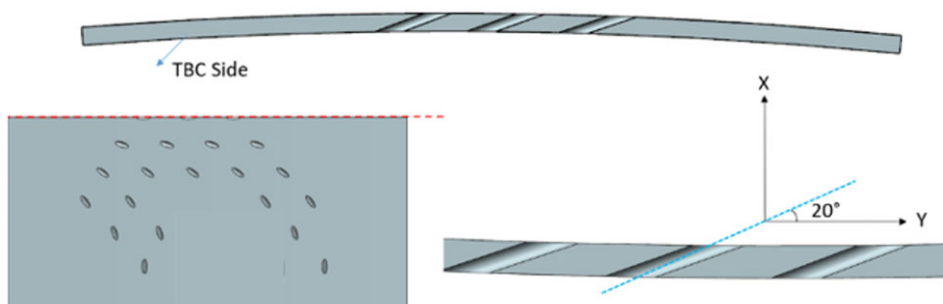
Figure 4. Effusion hole drilling angle.

Figures 4 and 5 show the drilling and orientation angles of effusion holes on the sample sheet. As shown in Fig. 5, the orientation angle is the angle that differs from the tangent of the cylindrical sample.

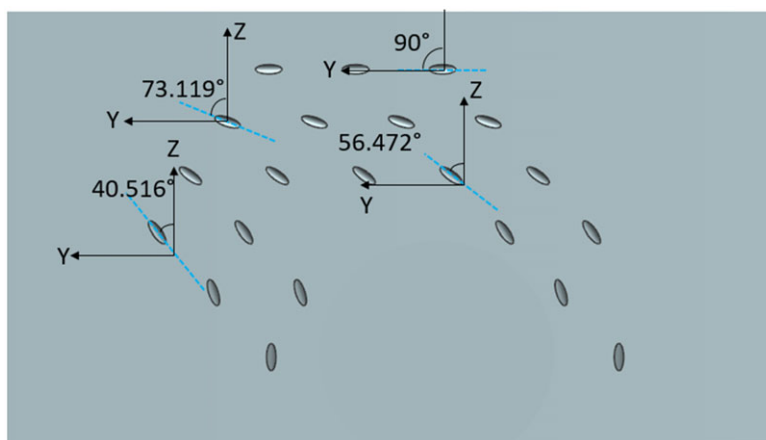
Figure 5. Effusion hole orientation angle.

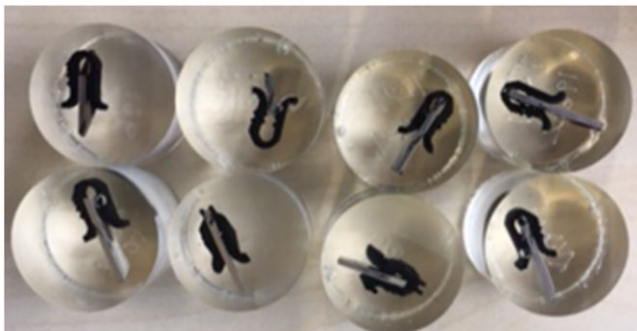
Figure 6. Microstructure study samples.

After drilling with the determined laser parameters, coupons were cut from the pieces and microstructure analysis was sent to metallography. In order to see the cooling hole microstructure, the samples were mounted in Bakelite and then polished until the hole cross-section was reached (Fig. 6).

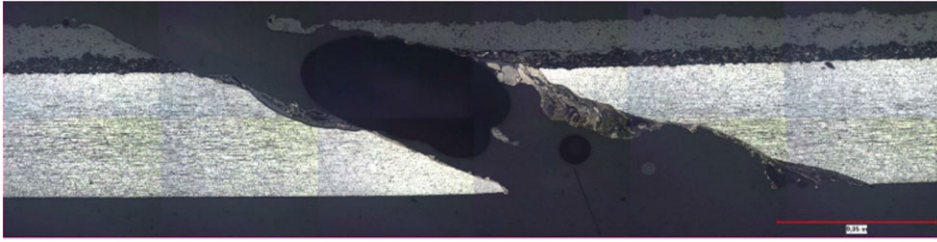
Figure 7. Recast Layer Coupon TL21-196-1 (500X).

The microstructure images of the effusion holes produced with different hole configurations and laser parameters are shown in the Figs. 7–12.

TL21-196-1	TL21-196-2	TL21-196-3	TL21-196-4	TL21-196-5	TL21-196-6
Average recast layer (mm)	0.295	0.361	0.394	0.328	0.307	0.264
Trans./longt. crack (mm)	0.109/ 0.429	0.170/ 0.406	0.173/ 0.754	0.292/ 0.912	0.264/ 0.511	0.114/ 1.4
Base material crack (mm)	0.02	None	None	0.018	None	None

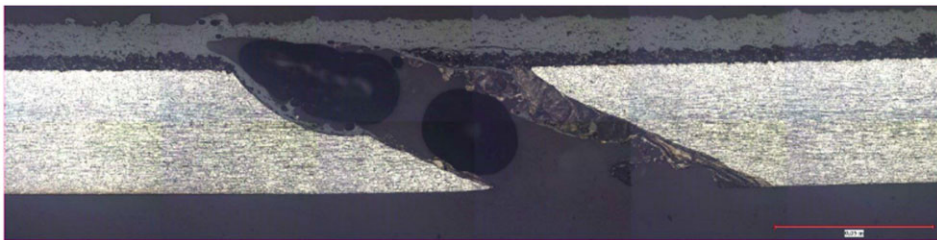
Figure 8. Recast Layer Coupon TL21-196-2 (500X).

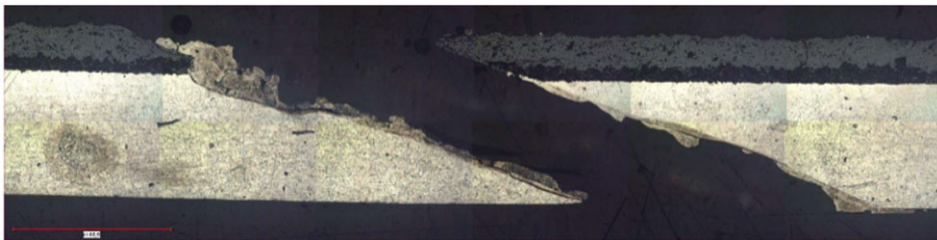
Figure 9. Recast Layer Coupon TL21-196-3 (500X).

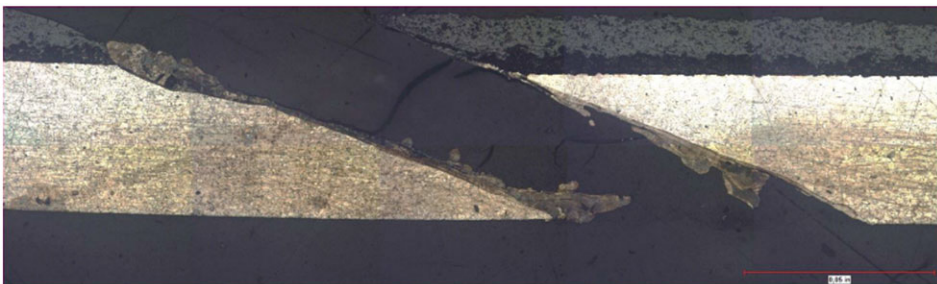
Figure 10. Recast Layer Coupon TL21-196-4 (500X).

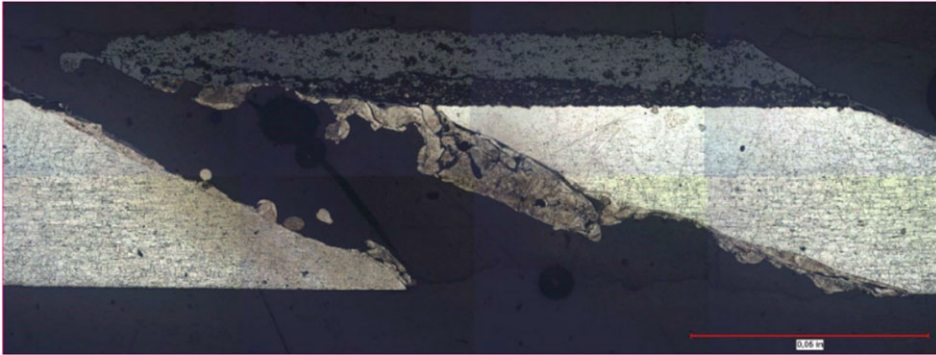
**Figure 11.** Recast Layer Coupon TL21-196-5 (500X).

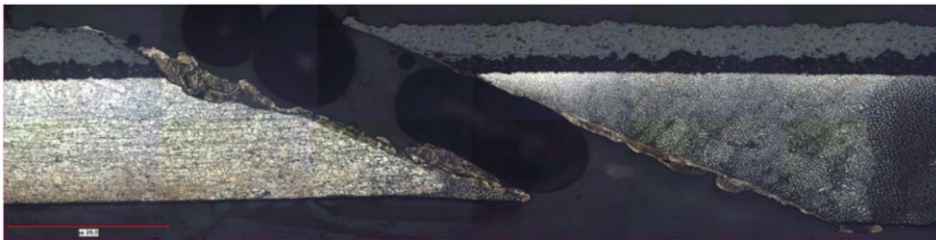
**Figure 12.** Recast Layer Coupon TL21-196-6 (500X).

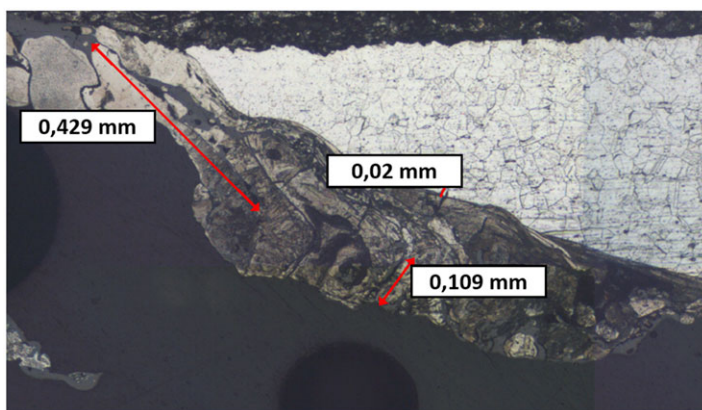
**Figure 13.** *TL21-196-1 Recast Layer and Microcracks in the Base Material.*

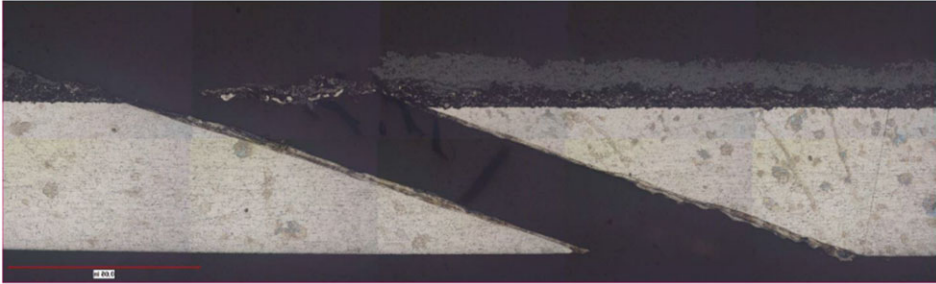
Figure 14. Recast Layer Coupon TL22-021-1 (500X).

samples with log numbers TL22-021-1 and TL22-021-2 produced with Tables 5 and 6 parameter sets are shown in Figs. 14 and 15. As it can be seen on the microstructure images, laser holes of the desired quality in terms of geometry and microstructure are achieved, especially in the TL22-021-1 coupon.

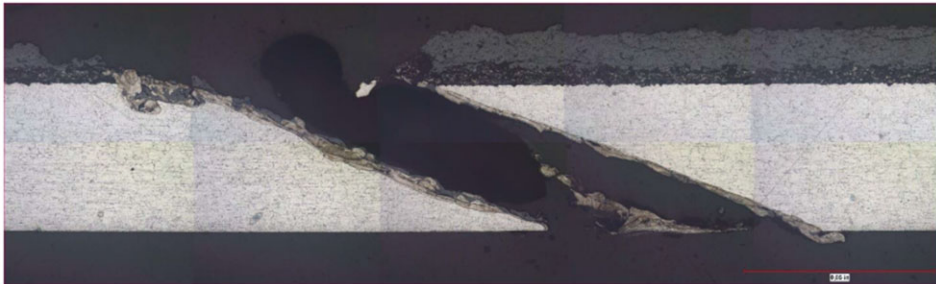
Figure 15. Recast Layer Coupon TL22-021-2 (500X).

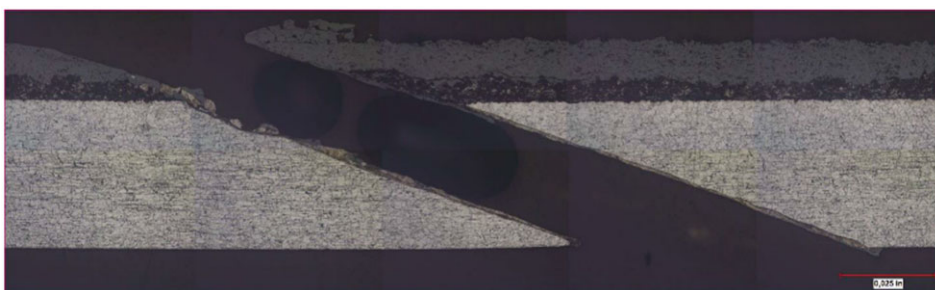
**Figure 16.** *Recast Layer Coupon TL22-055-1 (500X).*

of section cut geometry and recast layer differences. The microstructure images of the samples with log numbers TL22-055-1 to TL22-055-5 are shown in Figs. 16–20. The microstructure images show that all structures have the desired properties and that the results are comparable to literature work [9].

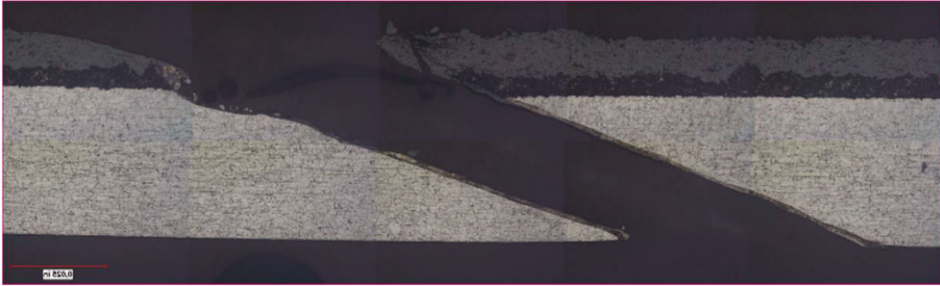
Figure 17. Recast Layer Coupon TL22-055-2 (500X).

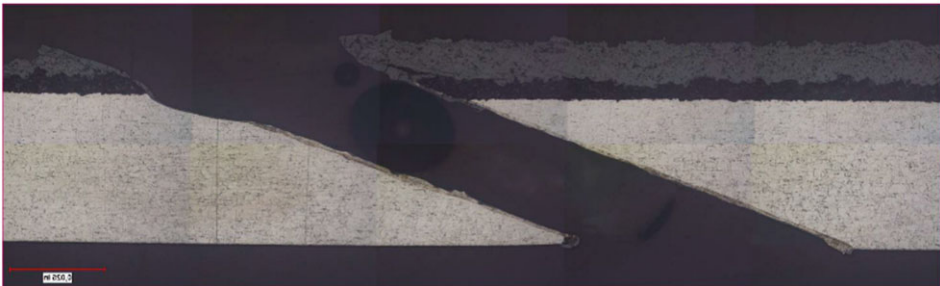
Figure 18. Recast Layer Coupon TL22-055-3 (500X).

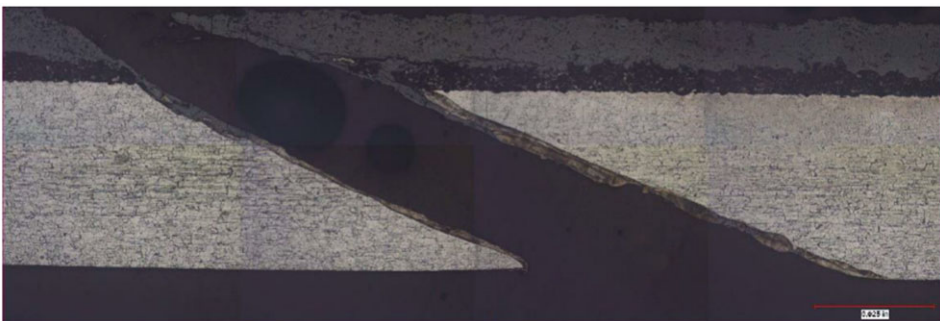
Figure 19. Recast Layer Coupon TL22-055-4 (500X).

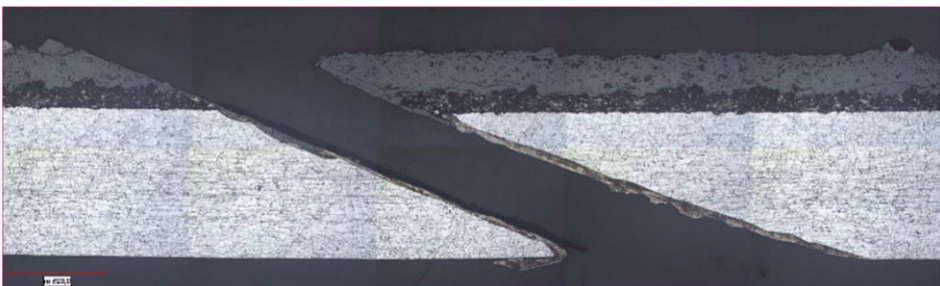
Figure 20. Recast Layer Coupon TL22-055-5 (500X).

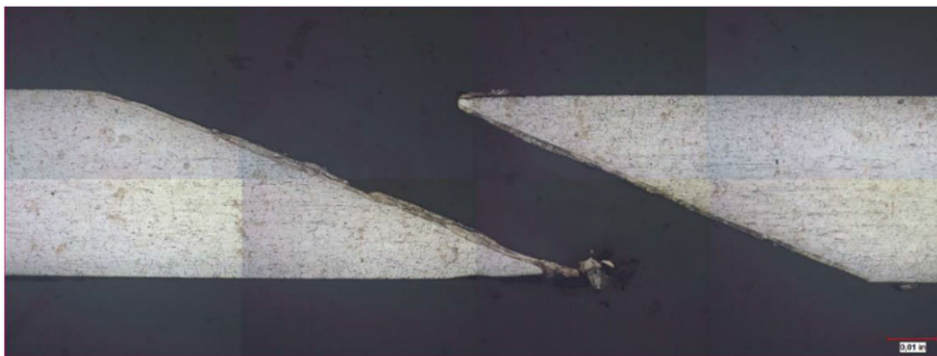
Figure 21. Recast Layer Coupon TL22-073-1 (without TBC, 500X).

The microstructure results obtained after this study (without TBC study) are shown in Table 12. The examination of the holes' geometric quality point out that they are suitable and reproducible as in the previous trials with TBC coating. The microstructure images of the samples with log numbers TL22-073-1 to TL22-073-4 are shown in Figs. 21–24.

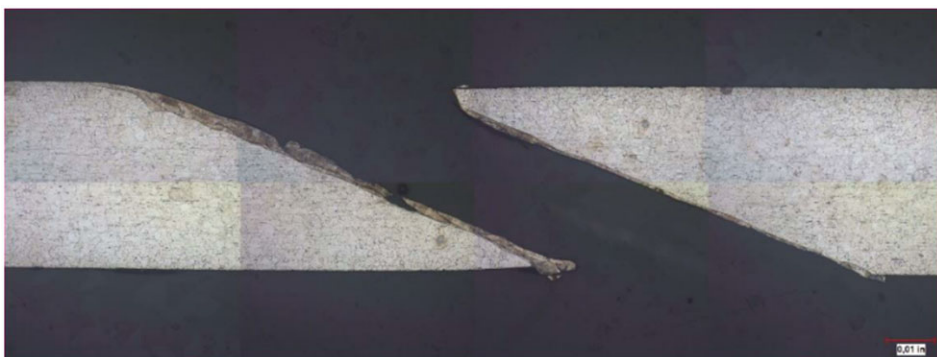
Figure 22. Recast Layer Coupon TL22-073-2 (without TBC, 500X).

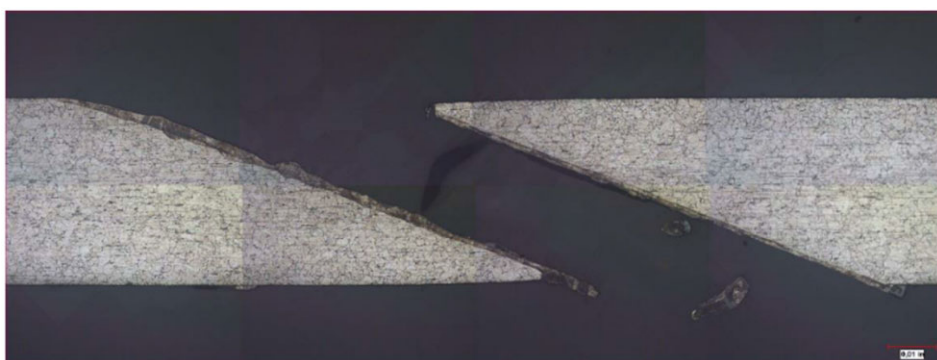
Figure 23. Recast Layer Coupon TL22-073-3 (without TBC, 500X).

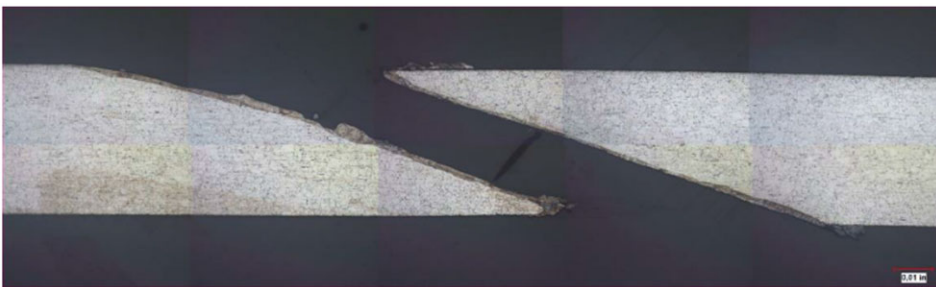
**Figure 24.** Recast Layer Coupon TL22-073-4 (without TBC, 500X).
