Netherlands Journal of Geosciences — Geologie en Mijnbouw | 86 - 3 | 257 - 271 | 2007

Downstream changes of meandering styles in the lower reaches of the River Vecht, the Netherlands

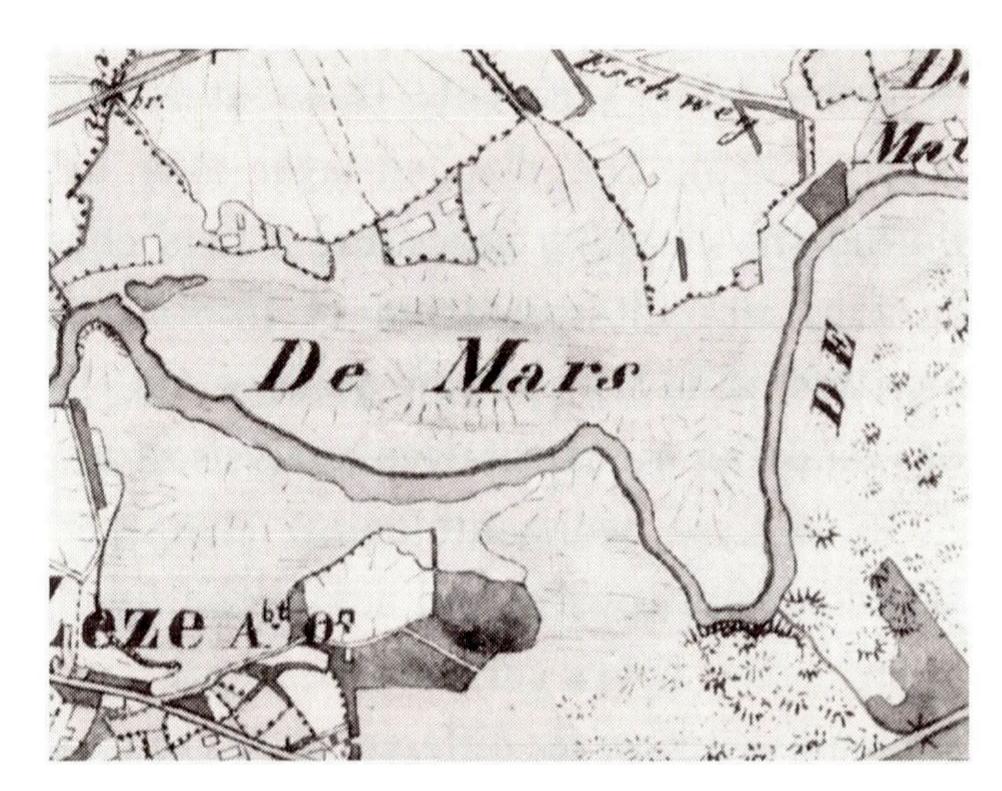
Fig. 3. Fragments of the historical maps used in this study: 1720 A.D., 1850 A.D., 1890 A.D (for location see Fig. 4).

The channel pattern of the River Vecht did not change dramatically in historical time: the 1720 channel pattern remained more or less unchanged until 1890 (Fig. 3). During the period 1720 - 1890, 6 meander cutoffs occurred, four of which were situated in reach A, one in reach B and one in reach C.
