HOW-TO SERIES

# Monitoring Shoreline Erosion at Calusa Island: A Community-Accessible Method

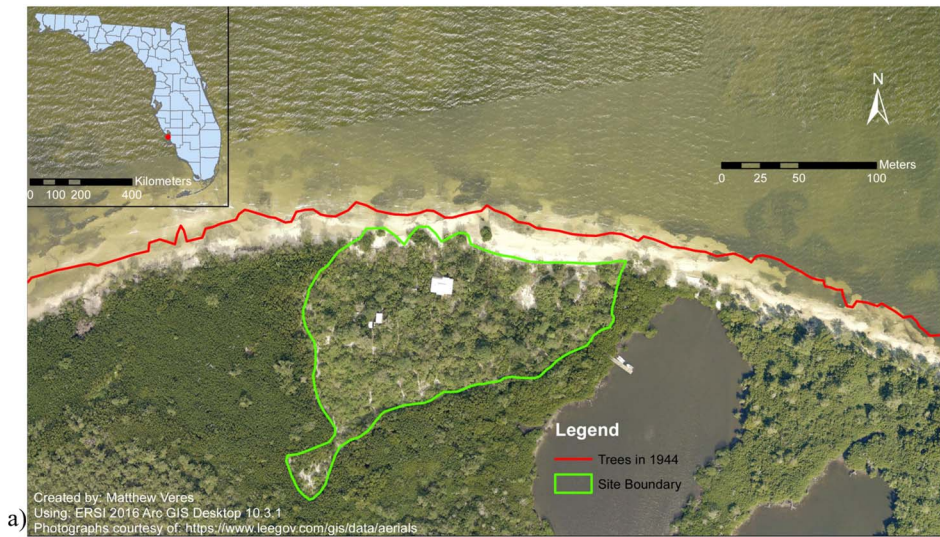
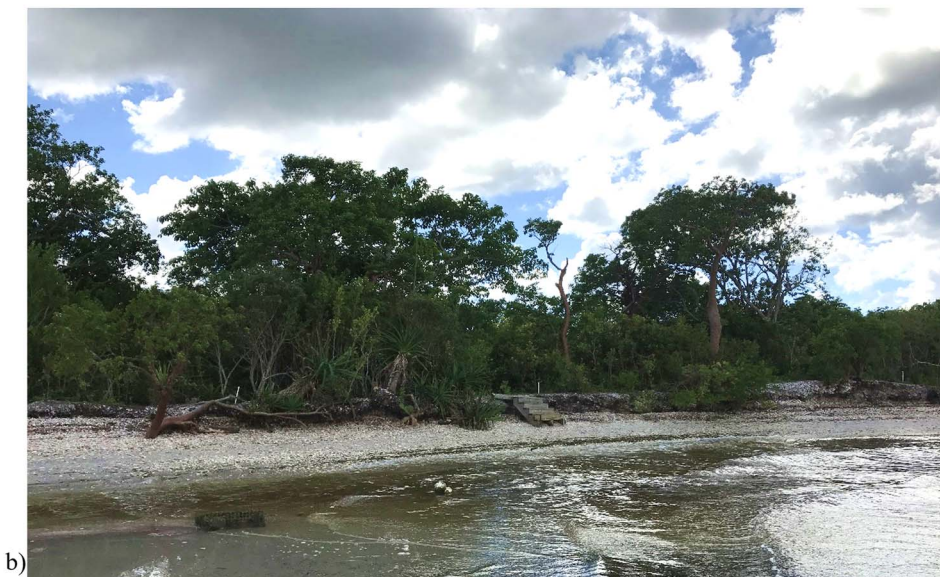
**Figure 1.** (a) Comparison of tree lines (coastline) between the 1944 USGS aerial photograph and the 2016 Lee County aerial photograph (from Haney et al. 2016); (b) photo of Calusa Island North Beach, October 13, 2017; (c) map of Calusa Island North Beach, including rebar indicated by letters and major landmarks across the beach.

The site is named after its location on Calusa Island, a diminutive island within the Pine Island Sound region (Figure 1a). Calusa Island is regionally unique within southwest Florida in preserving evidence of people and environments from the Terminal Archaic period, 1200–500 BC (Marquardt 1999; see Haney et al. 2016). “Calusa” is the name Spanish invaders recorded for the Indigenous communities that inhabited most of southwest Florida (Marquardt and Walker 2012). Today, there are two federally recognized descendant tribes that have land and reside in Florida: the Seminole Tribe of Florida and the Miccosukee Tribe of Indians of Florida. The Calusa Island Midden site spans parcels privately owned by individuals and the Calusa Land Trust (CLT), an organization dedicated to the protection of “the natural diversity and beauty of the Pine Island region” (Calusa Land Trust 2023). Long-term collaborations in heritage preservation between the Florida Public Archaeology Network (FPAN), the Florida Museum of Natural History (FM) Randell Research Center (RRC), and the CLT provide the foundation of the work presented here. Future efforts in site monitoring will continue to include collaborative input from a variety of heritage management and preservation experts, as well as local and descendant communities.

island visitors. The rebar locations were tied into a local grid system established by island residents and then referenced to prominent landscape features along the shoreline, providing the spatial foundations for the monitoring protocol (Figure 1c). Some rebar were since removed by natural forces or visitors; however, because the original locations were documented they were easily replaced. In 2019, the rebar locations were geolocated using a total station as part of a site-wide survey.

Measure the midden edge using rebar. There are nine rebar along the midden (Figure 1c). Carefully follow the protocol in Table 1 and see Figure 2a–c to ensure accurate and consistent measurements.

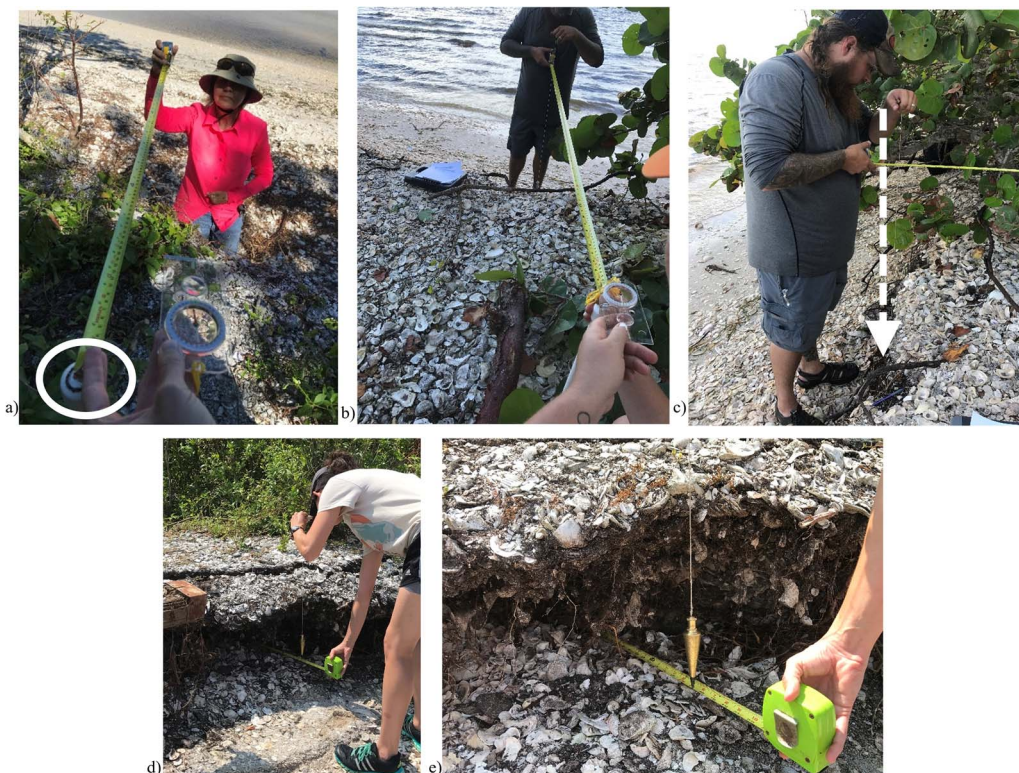
**Figure 2.** (a-c) Procedures for measuring midden edge using rebar; (d,e) measuring an undercut.

Measure the Midden Edge Using Rebar	
Step 1	Place the end of the measuring tape aligned with the middle of the top of the rebar. Your tape should not hook on the back of the rebar: it needs to be in the middle of the cap and on top of the rebar (not along the ground; <a href="#">Figure 2a</a> ).
Step 2	The person on the other end of the tape should pull it generally to the edge of the midden.
Step 3	The partner at the rebar, using the compass, should align your partner so he or she is due north of the rebar; the measuring tape should also be aligned due north ( <a href="#">Figure 2b</a> ).
Step 4	Keeping the tape as level as possible, parallel to the ground, the person on the midden edge should use the plumb bob so the point is hanging freely but grazing the edge of the midden. The string of the plumb bob should be grazing the measuring tape, not resting on it. If the string is bent or loose, you need to readjust it so it hangs freely. Use the string of the plumb bob to measure the edge of the midden (wherever the string aligns with the measuring tape is your measurement; <a href="#">Figure 2c</a> ).

Step 5	Record your measurements on the Rebar Measurements form.
Measure the Undercut	
Step 1	Take your midden-edge measurement using this protocol. Then, make a mental note of exactly where your plumb bob came to the midden edge.
Step 2	At the spot where the bottom of the plumb bob touched, place the top (the string just below your hand) with the plumb bob hanging to the ground.
Step 3	Keeping the plumb bob hanging from that spot, you need to extend your measuring tape, lock it so it doesn't slide closed. Put the end of the measuring tape at the <i>deepest point</i> of the midden overhang, where the cut is deepest. The measuring tape should point straight back at the rebar, keeping your previously established due north line. Use the end of the plumb bob, dangling freely, to graze your measuring tape ( <a href="#">Figure 2d,e</a> ).
Step 4	Record the measurement on the Rebar Measurements form.

**Solution:** We added the use of a compass to ensure systematic collection of measurements from each rebar due north to the eroding edge (Figure 2a,b)

**Solution:** We introduced use of a plumb bob to control the vertical line from tape to the erosion edge to ensure it is consistently vertical (Figure 2c).

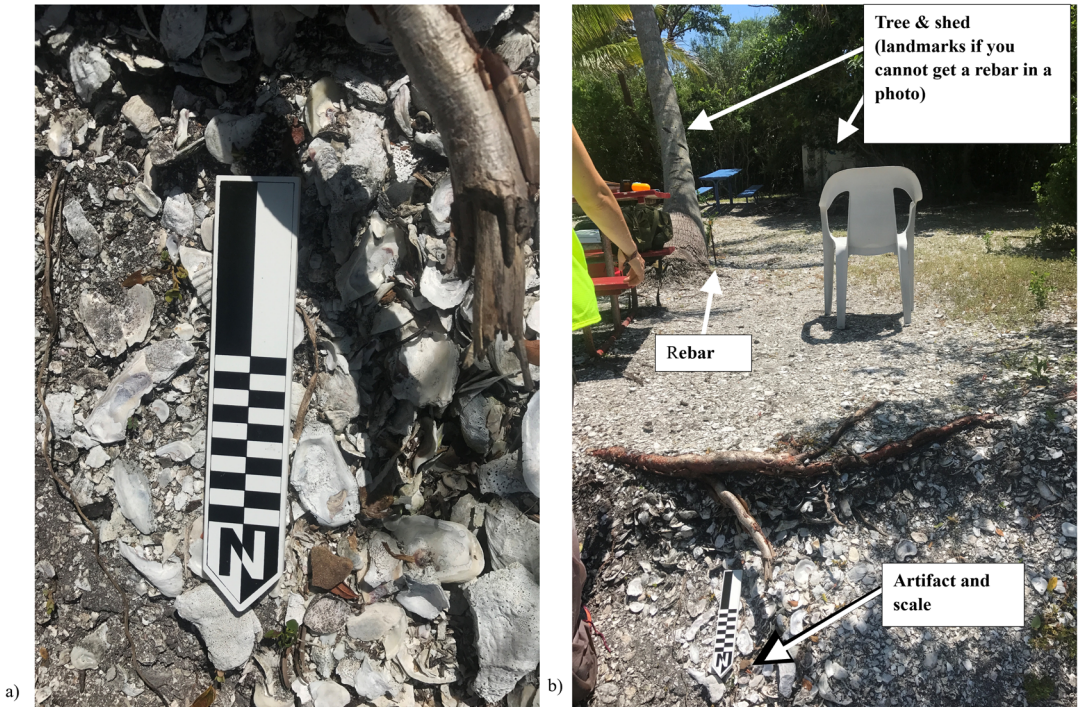
Figure 4. Artifact photos: (a) close-up; (b) context.

- (1) Close-up with scale north arrow and artifact. This is to help visually identify the artifact with some detail (Figure 4a).
- (2) Context with scale north arrow and artifact. This photo is to tie the artifact in with large or fixed landmarks that are easy to find, like large trees, the shed near the picnic area, the stairs, or a rebar (Figure 4b).

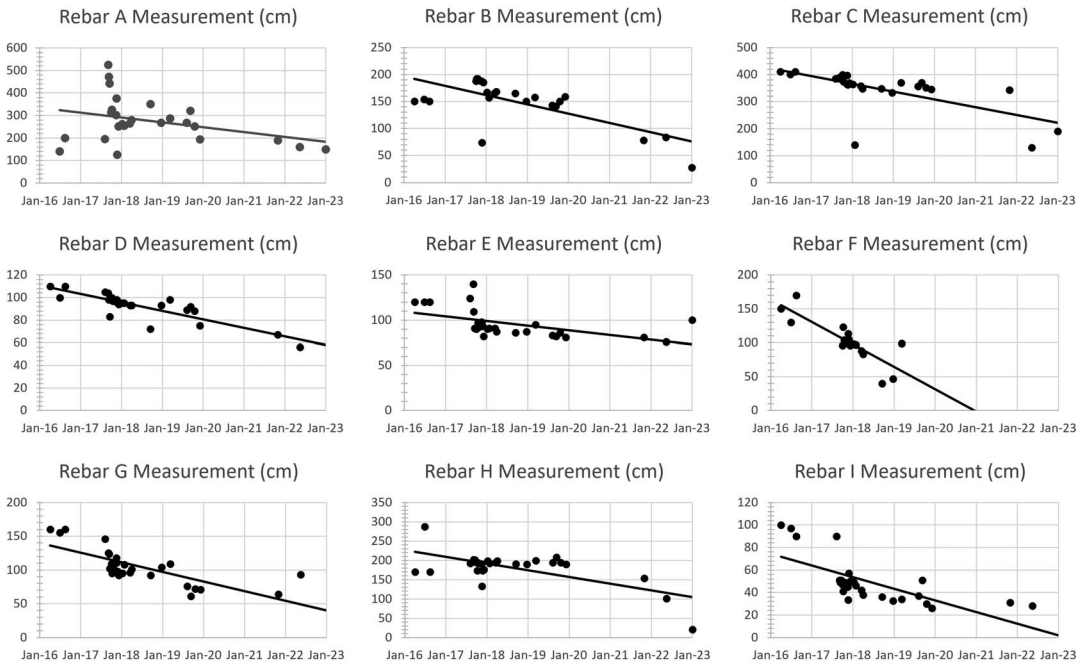
Figure 5. Calusa Island rebar data from April 2016 through January 2023. Each rebar measurement is represented by a single dot, and trend lines show the trends for each rebar. The y axis indicates measurements in cm; the x axis notes January of each year (for example, Jan 16 represents January 2016). For exact dates and measurements see Table 2. Note anomalous measurements but overall trends of declining measurement indicating erosion.

This methodology produced data that document trends when analyzed over numerous years and anomalies after a large erosional event, such as a hurricane (Figure 5). The varying techniques that introduced error prompted us to update our protocol multiple times (Walker 2016). Many issues we encountered would be easily avoidable for new projects. The following issues caused inconsistencies in the data and were addressed in the following ways:

Based on the data collected at Calusa Island to date, we can make two important assertions. First, there is a clear negative correlation between the distance from the rebar to the edge of the midden and time (Table 2; Figure 5), which suggests severe erosion at the site. Data gathered from April 2016 to January 2023 show that the rebar-to-edge measurement is declining at an average rate of 77 cm (2.5 ft.) per year (see trendlines in Figure 5). This illustrates the threat to the site posed by major storms and day-to-day erosion. Second, although the midden covers the entire North Beach area, there is significant variability in terms of in situ artifact exposure and distribution documented using the section letters assigned to each rebar, suggesting differing archaeological site components (Figure 1c data available on request from the FM).

Note: Dates are mm/dd/yyyy. All measurements are in cm. The first column of each letter indicates measurement from the lettered rebar to the eroding edge; the second column of each letter documents undercut measurements. Em-dashes indicate no measurement taken due to missing rebar. 0 indicates no undercut noted. See [Figure 5](#) for graphs and trend lines.

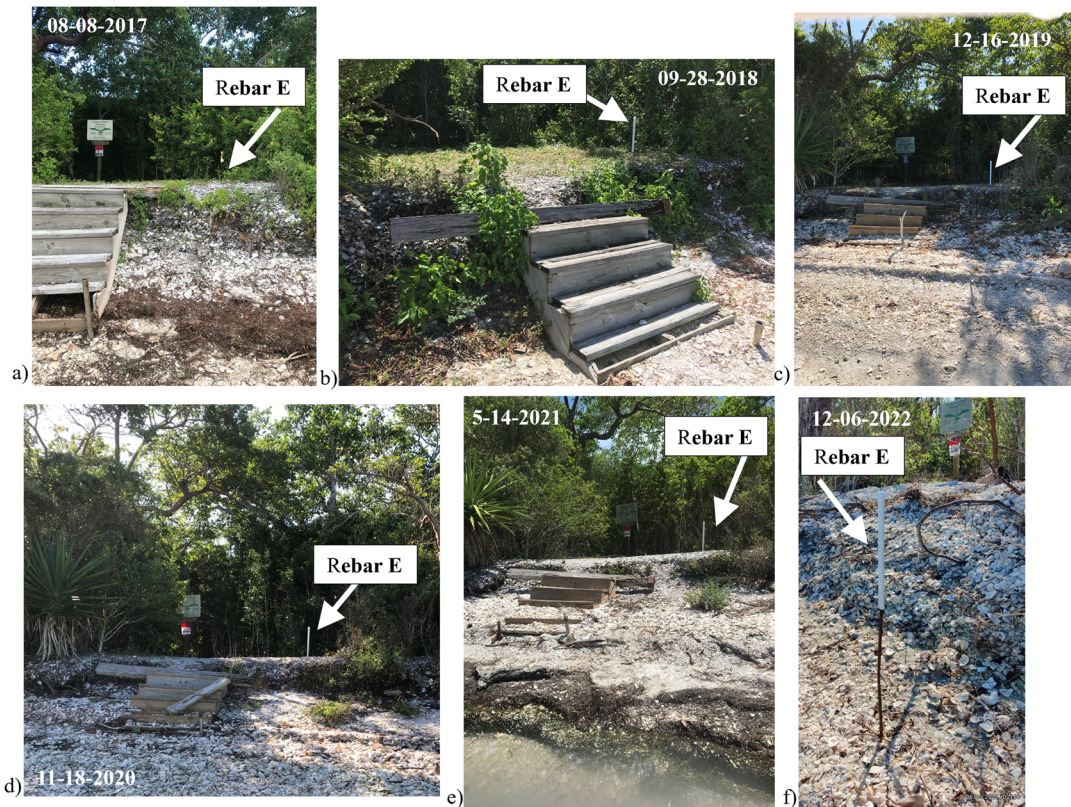
**Figure 6.** Rebar E and staircase images from 2017 to 2023. Notable hurricanes during that time were Irma on August 18, 2017, and Ian on September 28, 2022. The staircase was no longer present after Ian, and the midden had eroded 100 cm past the rebar.

(Figure 6a,b). Additionally, a significant amount of shell material from the sound was deposited on parts of the beach. These deposits impeded our ability to define the full extent of erosion prior to their deposition; however, they now provide a temporary measure of protection by partially covering erosional edges of the midden.

Most Calusa Island volunteers were displaced from their homes, lost property during the storm, or both, and Calusa Island was inaccessible for weeks. FPAN archaeologists were not able to monitor the site until December 6, 2022, followed by another site visit with RRC archaeologists and CLT members in January 2023. The first visit focused on locating and assessing the contextual integrity of the rebar and documenting overall damage to the North Beach midden area. Many of the rebar survived the storm without alteration, but all experienced corrosion and showed signs of deterioration. Rebar F had been displaced before the storm (likely by visitors to the island), Rebar D and G were missing or displaced after the storm, and the midden surrounding Rebar E and I had eroded past the rebar.
